Site Investigation and Drainage Report

Site	Holy Trinity Church Church Road Potten End Berkhamsted HP4 2QY Ref: L/019/58338/S
Client	Ecclesiastical Insurance Group c/o GHG
Date	23.10.19
Our Ref	11053

SUBSIDENCE ENGINEER'S REPORT

Client Name	Ecclesiastical Insurance Group
Reference	378768
Name of Insured	Vicar/CHNS/PCC Potten End, Holy Trinity
Policy Number	04/XPG/0259708
Risk Address	Holy Trinity Church, Church Road, Potten End, Berkhamsted, Hertfordshire, HP4 2QY

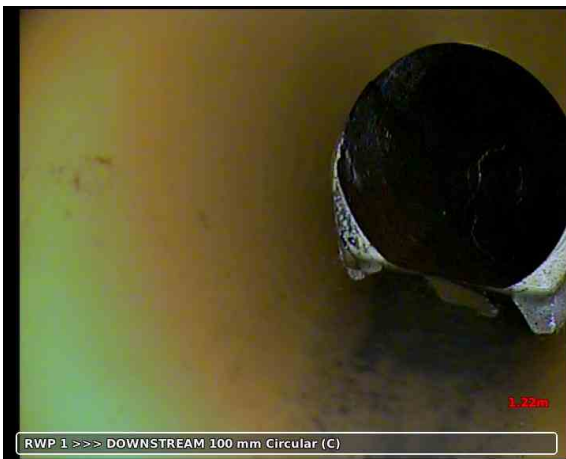
20191023-085610-snap0002.jpg, 00:00:53, 1.22 m
Joint displaced, medium

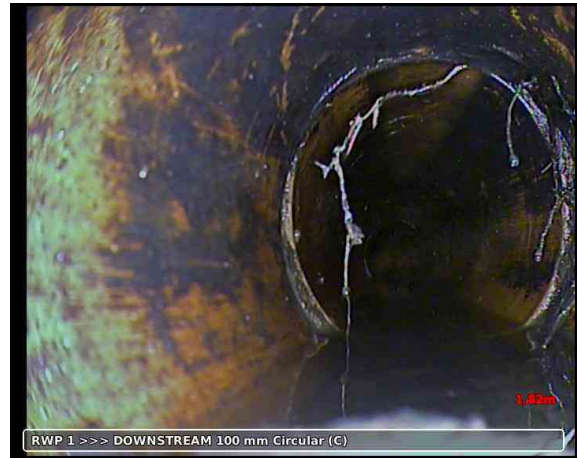
20191023-085610-snap0005.jpg, 00:01:21, 1.82 m
Roots, fine at joint

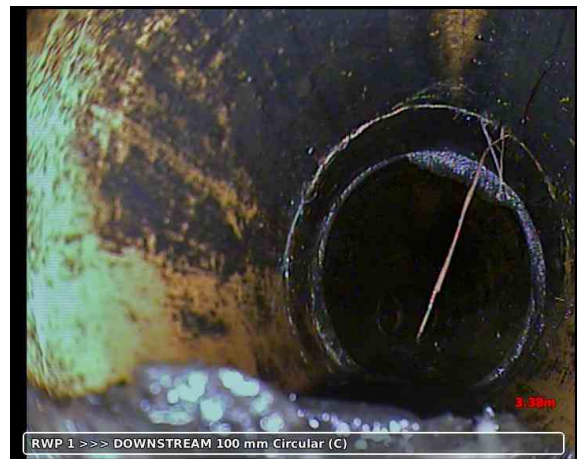
<table><tr> <td style="text-align: right;">0.00</td> <td style="text-align: center;">GY</td> <td>Start node type, gully, reference number: 1</td> <td style="text-align: right;">00:00:03</td> <td style="text-align: right;">20191023-085610-sn-ap0000.jpg</td> <td></td> <td></td> </tr><tr> <td style="text-align: right;">3.38</td> <td style="text-align: center;">CC</td> <td>Crack, circumferential, from 12 to 12 o'clock</td> <td style="text-align: right;">00:02:04</td> <td style="text-align: right;">20191023-085610-sn-ap0007.jpg</td> <td style="text-align: center;">2</td> <td></td> </tr></table>

20191023-085610-snap0007.jpg, 00:02:04, 3.38 m
Crack, circumferential, from 12 to 12 o'clock

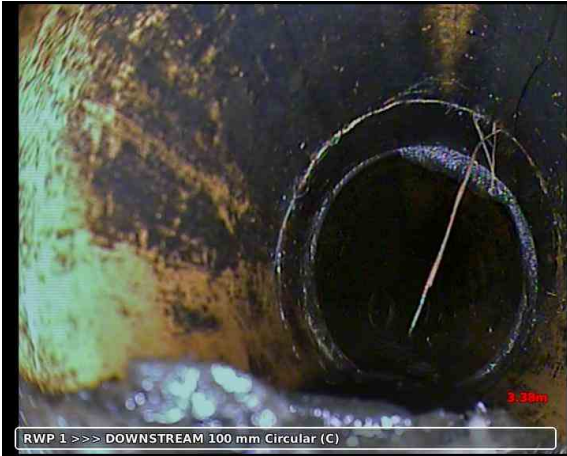
20191023-085610-snap0008.jpg, 00:02:21, 3.38 m
Roots, fine

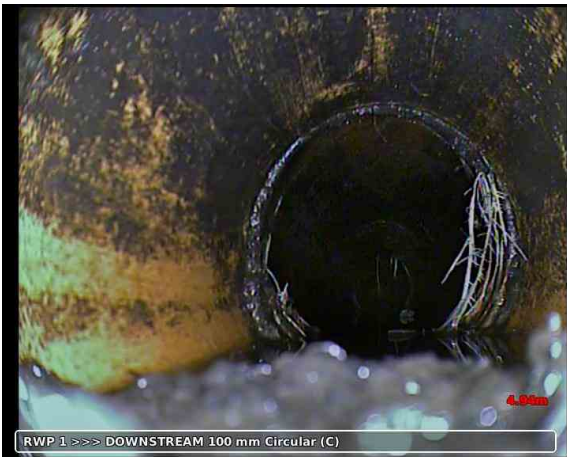
20191023-085610-snap0010.jpg, 00:03:00, 4.94 m
Roots, tap at joint

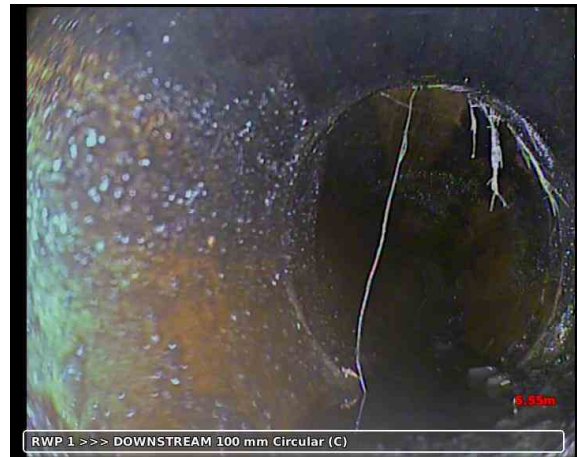
20191023-085610-snap0011.jpg, 00:03:25, 5.55 m
Roots, fine at joint

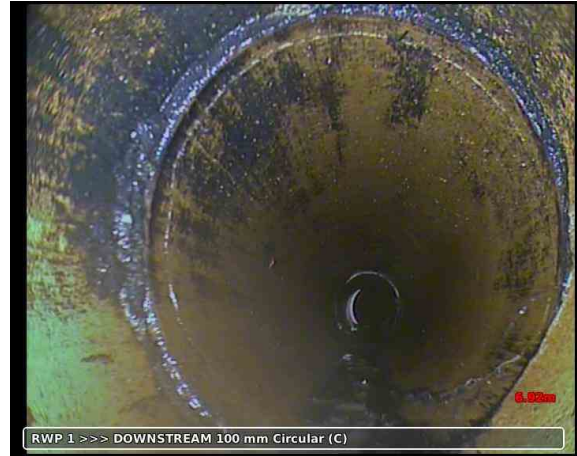
<table><tr> <td style="text-align: right;">0.00</td> <td style="text-align: center;">GY</td> <td>Start node type, gully, reference number: 1</td> <td style="text-align: right;">00:00:03</td> <td style="text-align: right;">20191023-085610-sn-ap0000.jpg</td> <td></td> <td></td> </tr><tr> <td style="text-align: right;">6.92</td> <td style="text-align: center;">CC</td> <td>Crack, circumferential, from 07 to 05 o'clock</td> <td style="text-align: right;">00:03:55</td> <td style="text-align: right;">20191023-085610-sn-ap0013.jpg</td> <td style="text-align: center;">2</td> <td></td> </tr></table>

20191023-085610-snap0013.jpg, 00:03:55, 6.92 m
Crack, circumferential, from 07 to 05 o'clock

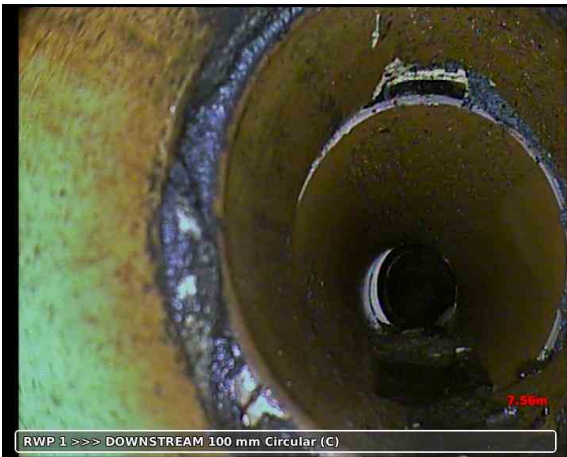
<p style="text-align: center;">DOWNSTREAM</p> <p>Depth: 0.00 m</p>		7.56	H	Hole in drain or sewer, at 12 o'clock	00:04:29	20191023-085610-sn-ap0014.jpg	4

20191023-085610-snap0014.jpg, 00:04:29, 7.56 m
Hole in drain or sewer, at 12 o'clock

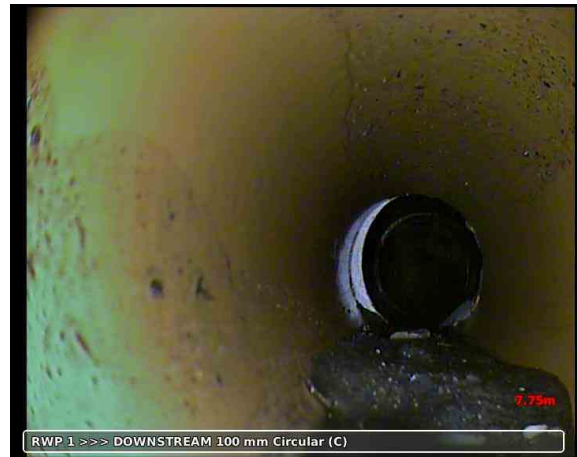
20191023-085610-snap0015.jpg, 00:04:50, 7.75 m
Settled deposits, fine, 10% % cross-sectional area loss

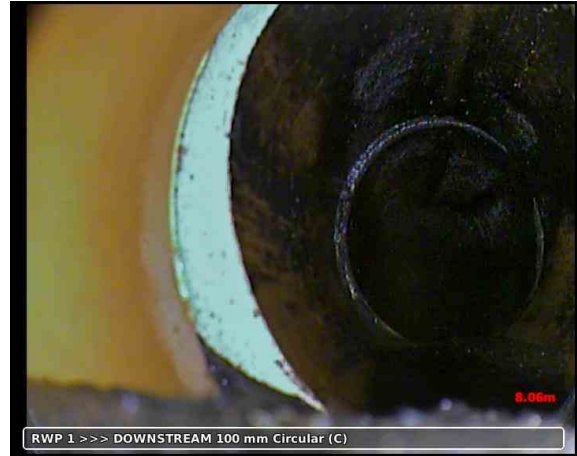
20191023-085610-snap0017.jpg, 00:05:35, 8.06 m
Joint displaced, medium

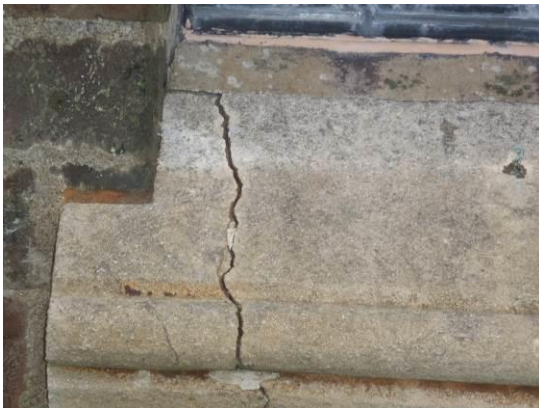
This photograph shows cracking in the sill to the right hand chancel window.

There is a substantial crack in the front end of the sill to the left hand chancel window being approximately 3mm in width, which does not appear to be subsidence related. It is also of some considerable age.

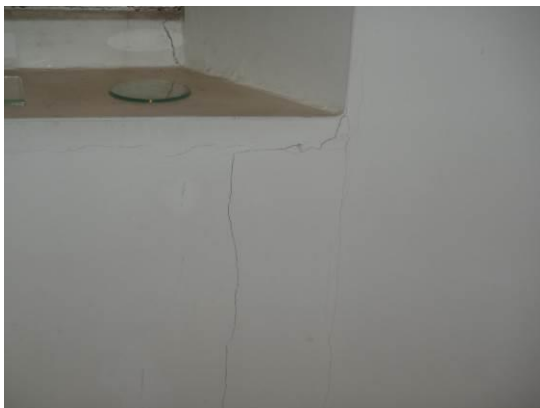
This photograph shows cracking below the bottom left hand side of the right hand chancel window.

There were two vertical cracks running down from the bottom left hand side of the right hand window, one being hairline and the other 1.5mm in width.

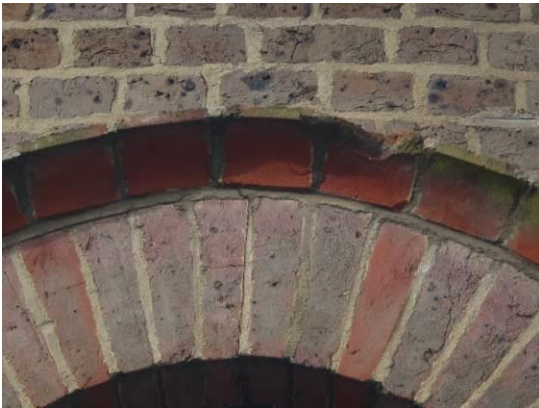
PHOTOGRAPH 05:

On this elevation we noted a crack running vertically up from the head of the central window vertically through the brick arch and then through mortar joints above. The crack was a maximum of 1.5mm in width.

This photograph shows cracking above the central chancel window.

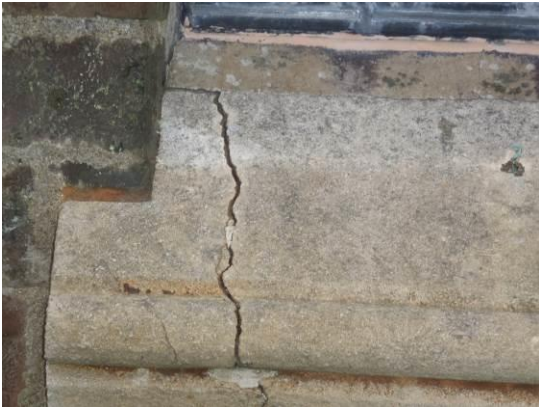
PHOTOGRAPH 06:

This photograph shows cracking in the sill to the right hand chancel window.

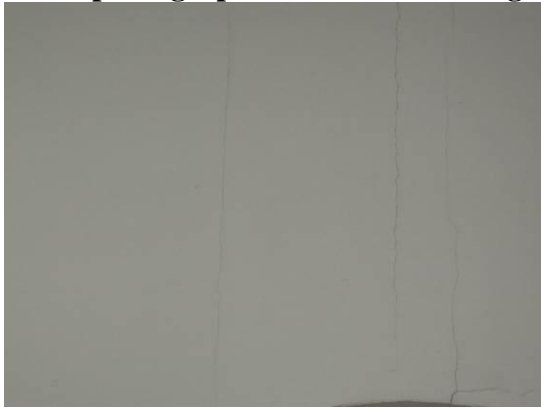
PHOTOGRAPH 07:

In this area we noted cracking within the curved chancel. There were three vertical cracks running up from the head of the central window, one of which extended into the reveal of the opening. These cracks were hairline to 0.5mm in width. There was also a vertical crack running down from each bottom left corner of this window again with a maximum width of 1.5mm.

This photograph shows the cracking above the central chancel window.

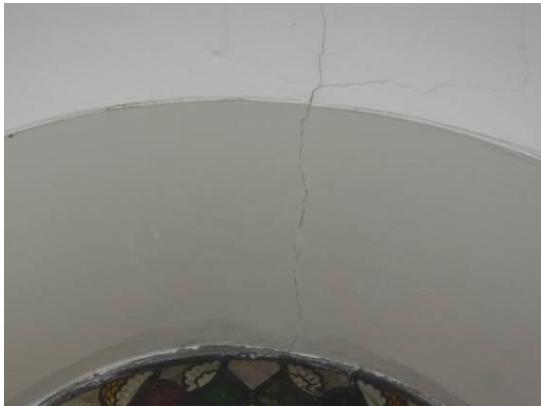
PHOTOGRAPH 08:

This photograph shows a continuation of one of the cracks in the previous photograph into the reveal of the central chancel window.

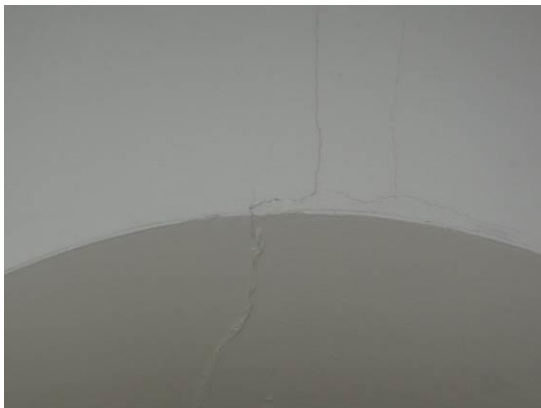
PHOTOGRAPH 09:

There was a single hairline crack running from ceiling down to windowsill level between the centre and left hand window and a single hairline crack running above the head of the left hand window.

This photograph shows the cracking above the left hand chancel window and its continuation into the reveal.

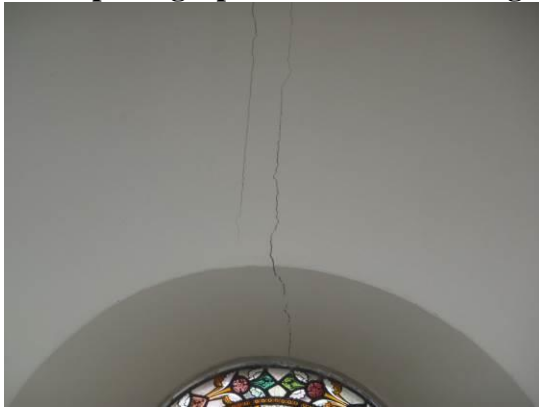
PHOTOGRAPH 10:

There were two significant cracks running up vertically from the head of the right hand window to ceiling level being a maximum of 2mm and 3mm in width respectively.

This photograph shows cracks above the right hand chancel window and its continuation into the reveal.

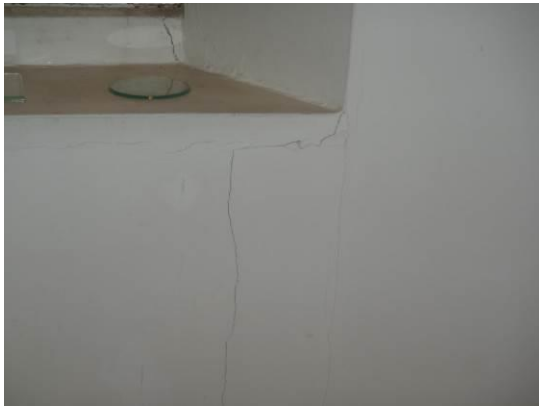
PHOTOGRAPH 11:

This photograph shows cracking below the bottom left hand side of the right hand chancel window.

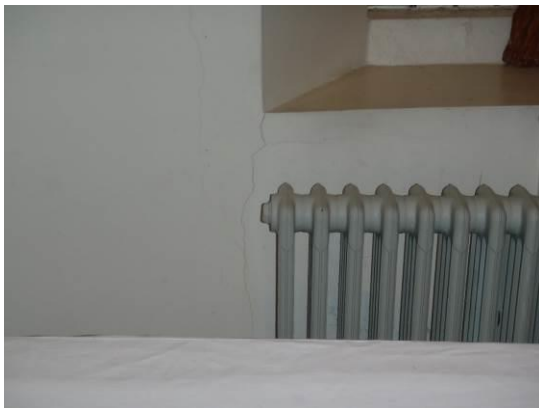
PHOTOGRAPH 12:

This photograph shows cracking running down from the bottom right hand corner of the central chancel window.
